Section 19 Flood Investigation

Bootle and Seaforth 30th September 2024

Executive summary

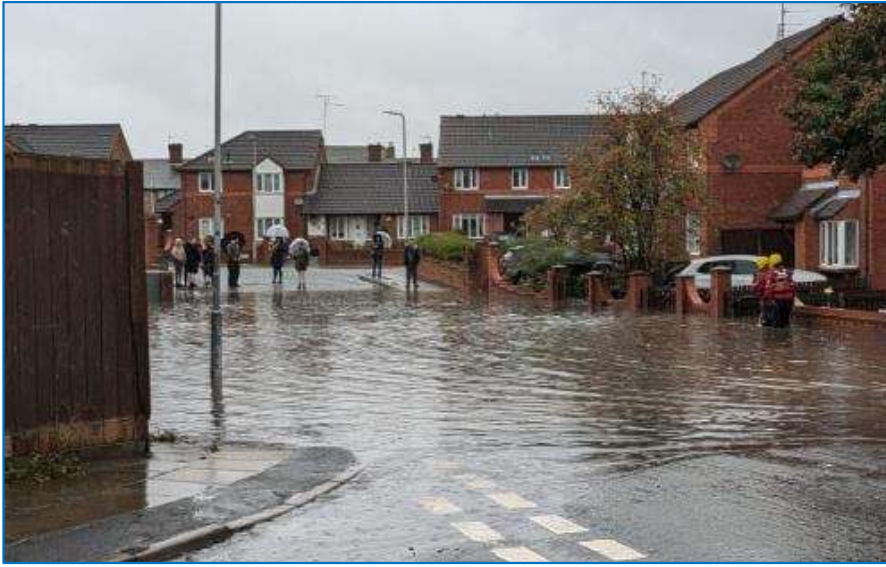
Figure 3: Flooding at the northern end of Bulwer Street/Bowles Street 30th September 2024

On the afternoon of the 30th September calls began to be received from residents and Merseyside Fire & Rescue Service to Sefton Council stating flooding of a significant depth was happening and entering residential properties and they wanted some assistance Figures 3. Residents had been advised by United Utilities (UU) to contact Sefton Council due to the heavy rain it will be surface water flooding. However, from past events in this area this extent of flooding has been caused by an issue on the combined sewer system. Sefton Council therefore contacted UU's incident room to explain this and advised them to send operatives to the site to investigate as foul sewerage was present.

Upon inspection by UU the flood waters were confirmed to be from the combined sewer system and UU took on the main responsibility of handling the flooding incident. It was observed that there was a failure on the system where the combined sewers and drains connect to the major drainage system called Mersey Estuary Pollution Alleviation Scheme sewer. At this junction, automated gates should operate on two outfalls which are designed to enable flows into the River Mersey when the system capacity would be exceeded, normally during storm conditions. Unfortunately, the gates in the outfalls operated by the automated system, appeared to be closed, causing the flood waters to back up and flood the highways and properties. The Fire Service, UU, Police and Sefton Council attended the area evacuating residents to safety and set up a rest centre for affected residents. UU enacted their manual override of the gates to open them, and the flood waters subsided quickly. Figures 3-8 show the impact of the event.

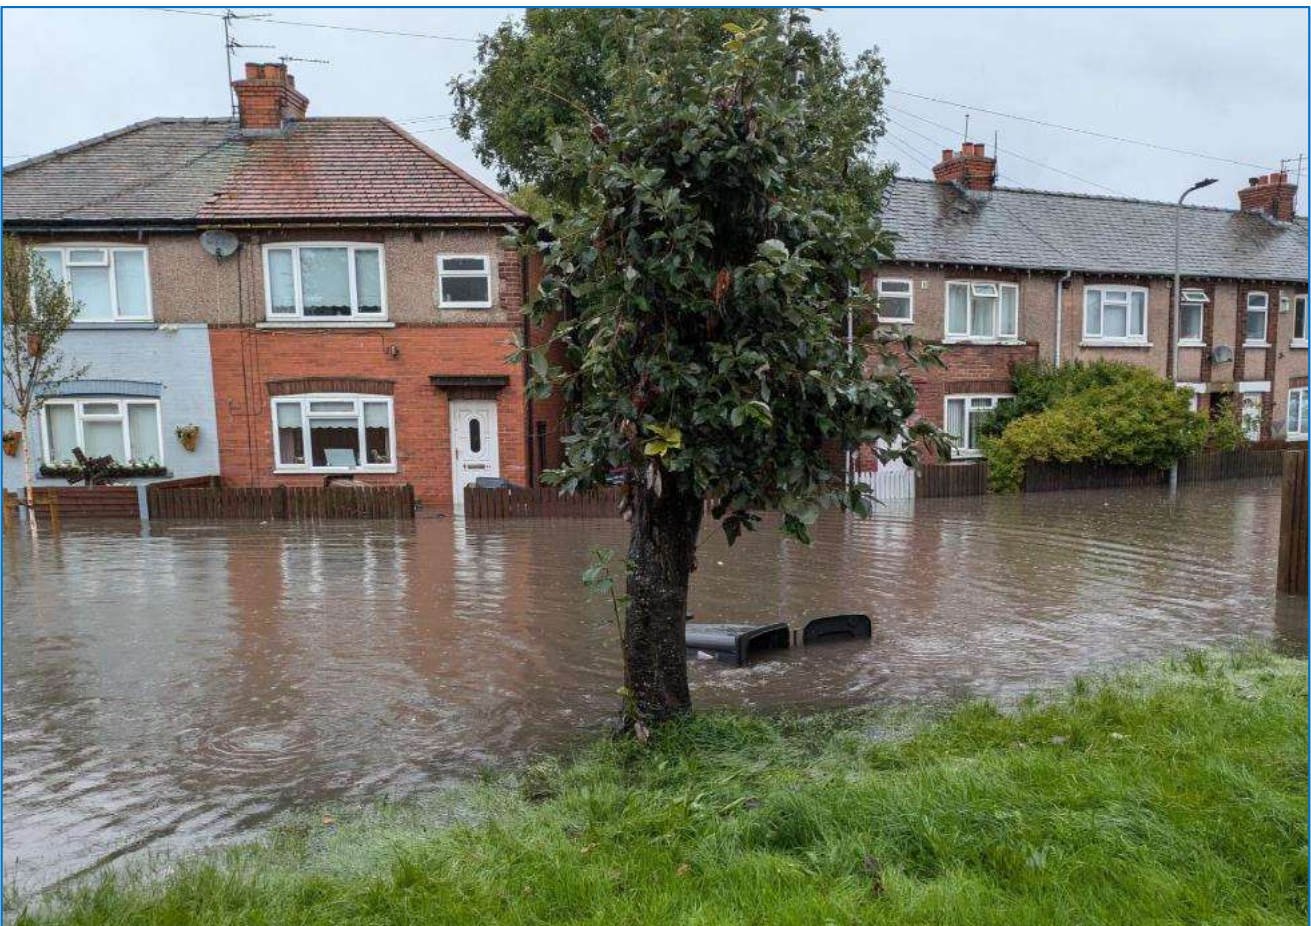
Figure 4: Flooding on Bulwer Street 30th September 2024

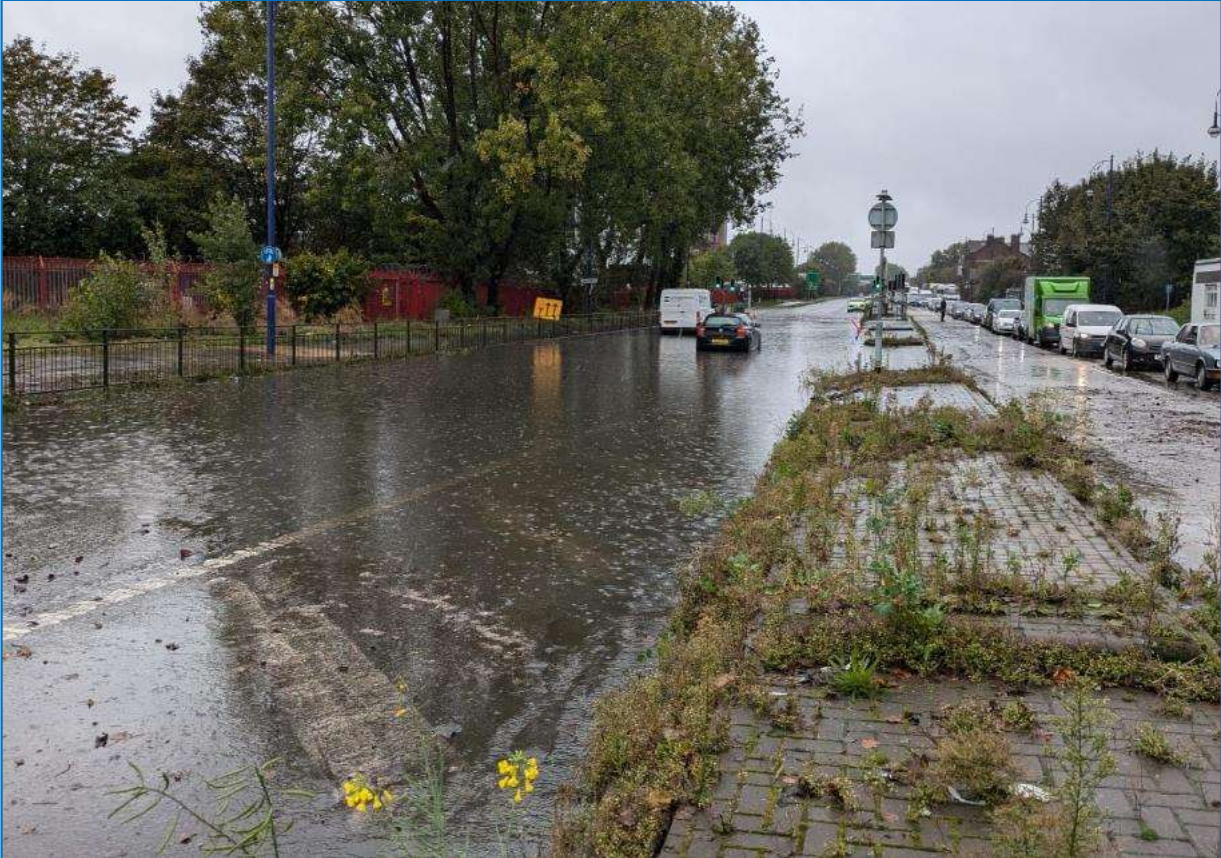
Figure 6: Flooding on Seaforth Road 30th September 2024

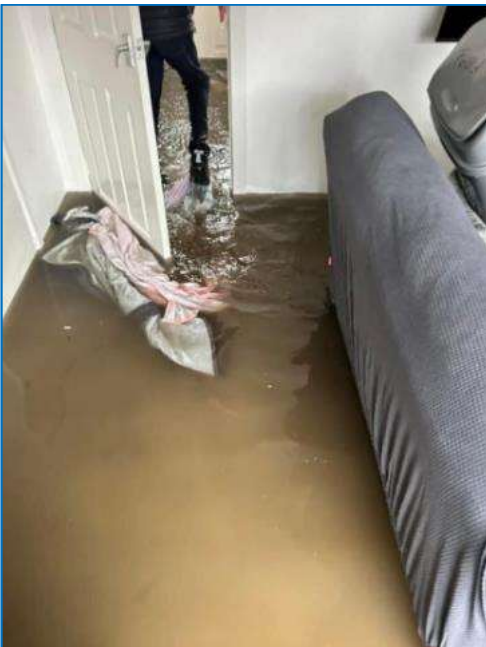
Figure 7: Internal flooding on Bulwer Street 30th September 2024

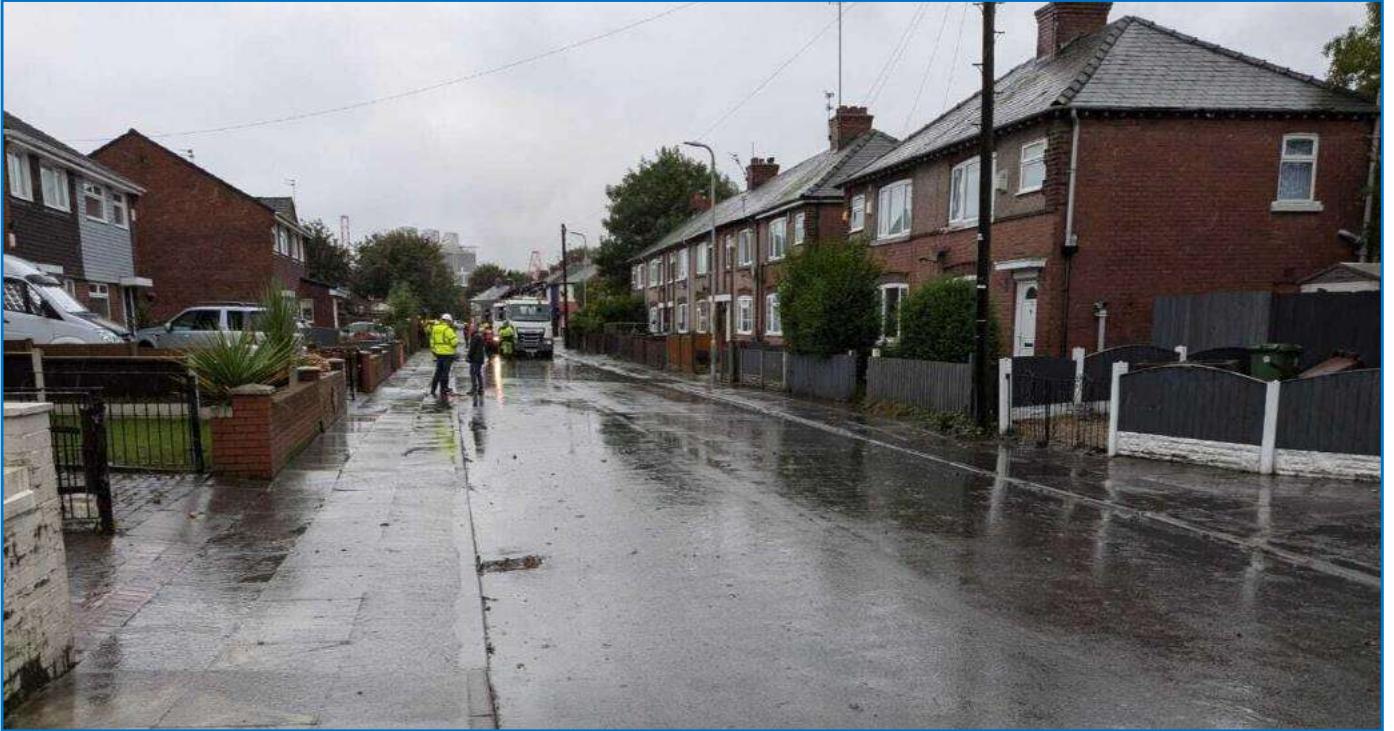
Figure 8: Bulwer street 30th September 2024 following manual operation override on system.
